## CP61 Trevaunance Cove

## Before and After Photos for Trevaunance Cove, St Agnes

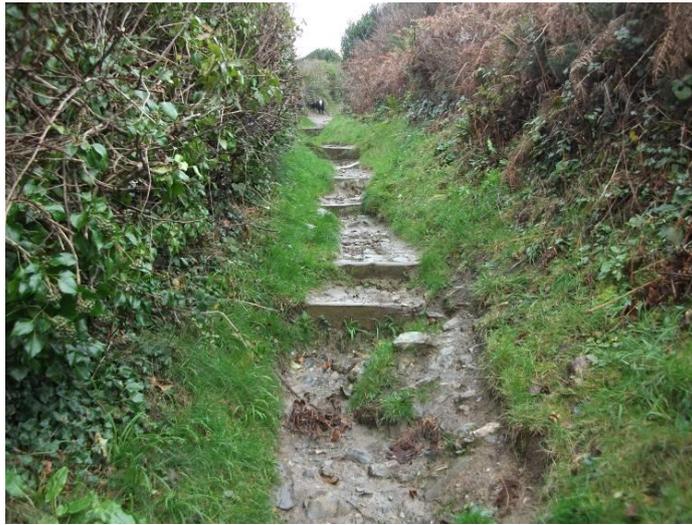
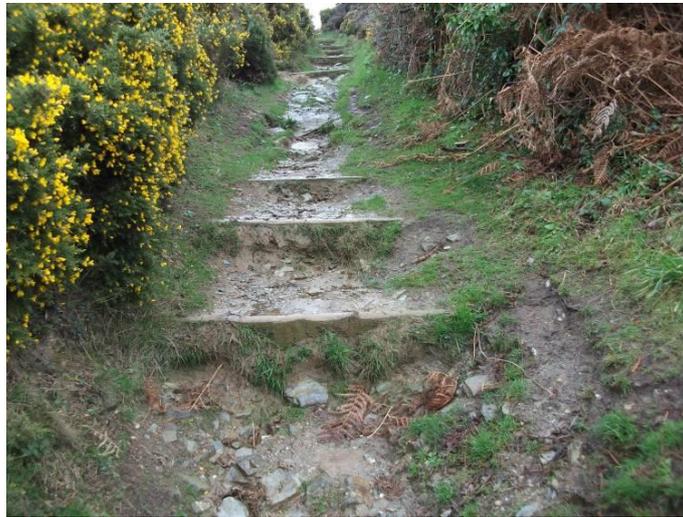
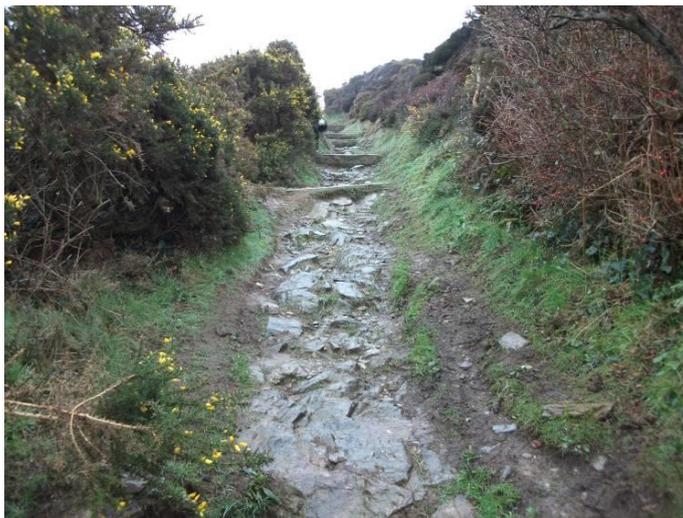
The short but steep section of coast path here has been difficult to negotiate for a long time.

Photos showing the old wooden steps and protruding granite along the footpath.

The project brief consisted of removing the old steps, replacing them with new granites and improving the drainage.

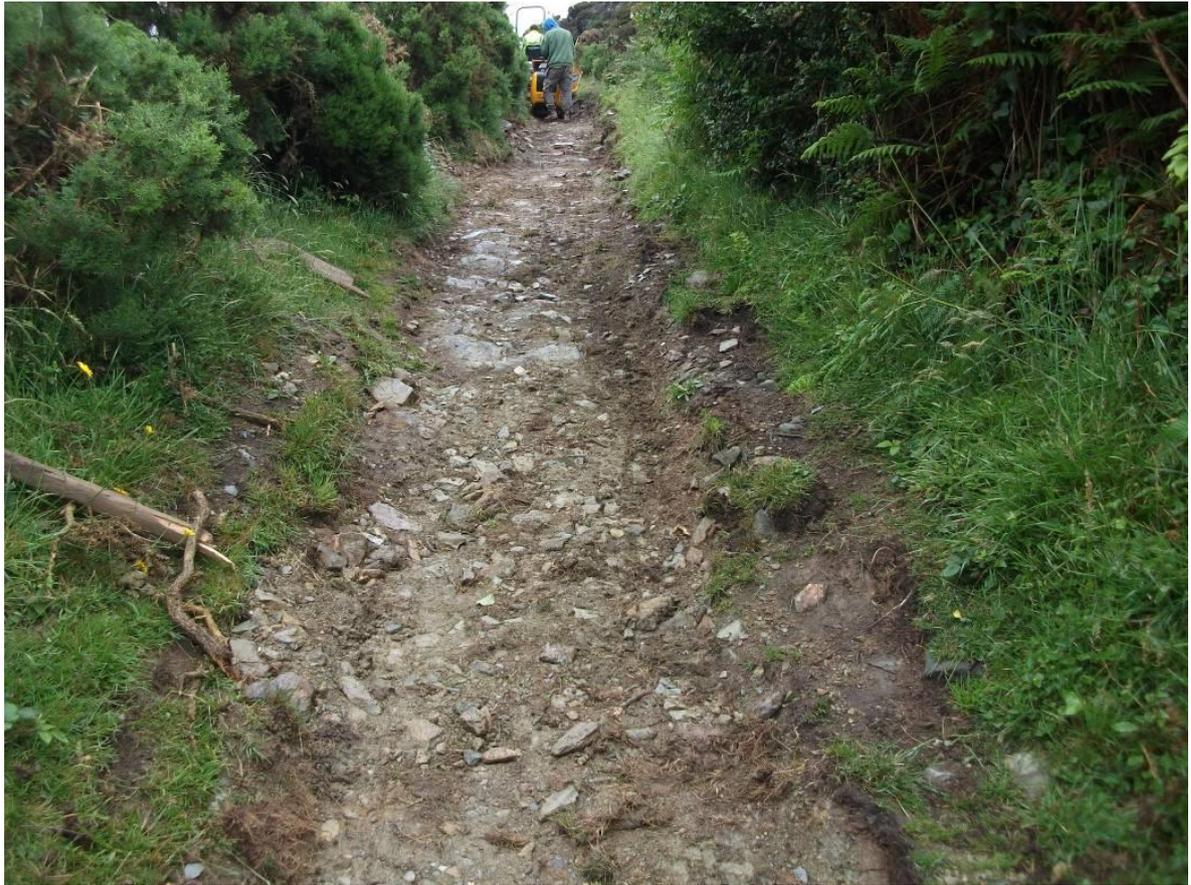
This photo was taken during the works after the wooden steps had been removed. The ground was levelled out and the path widened.

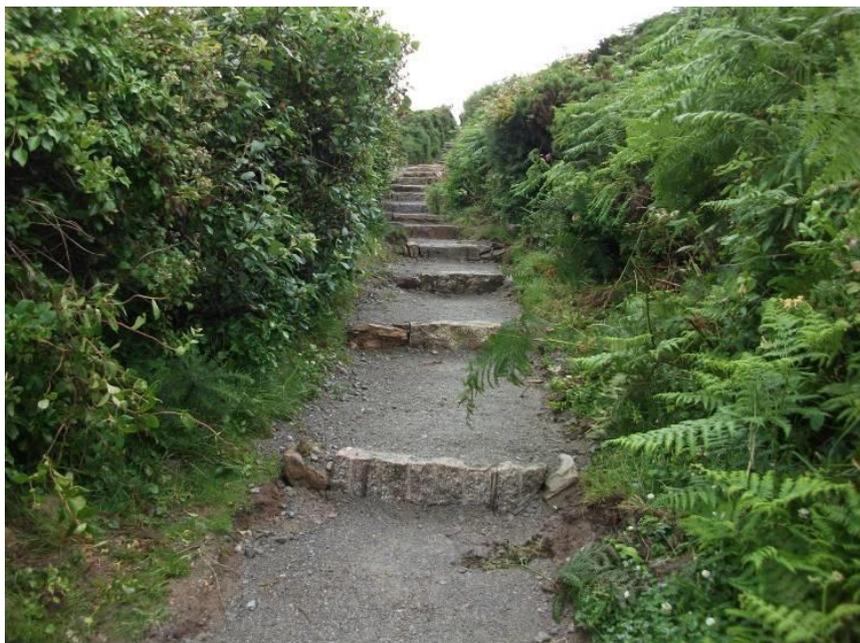
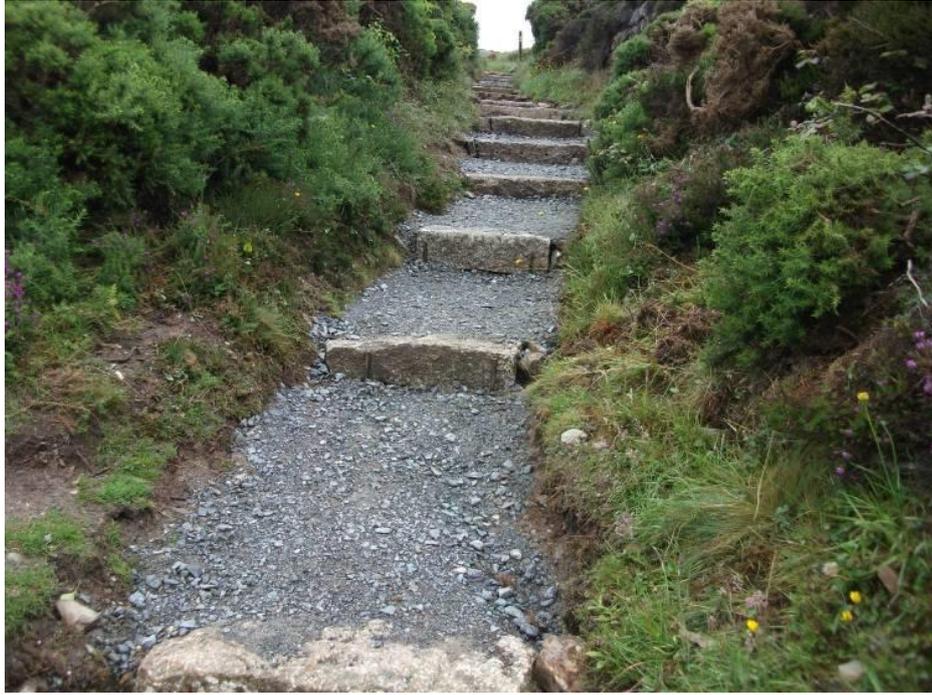
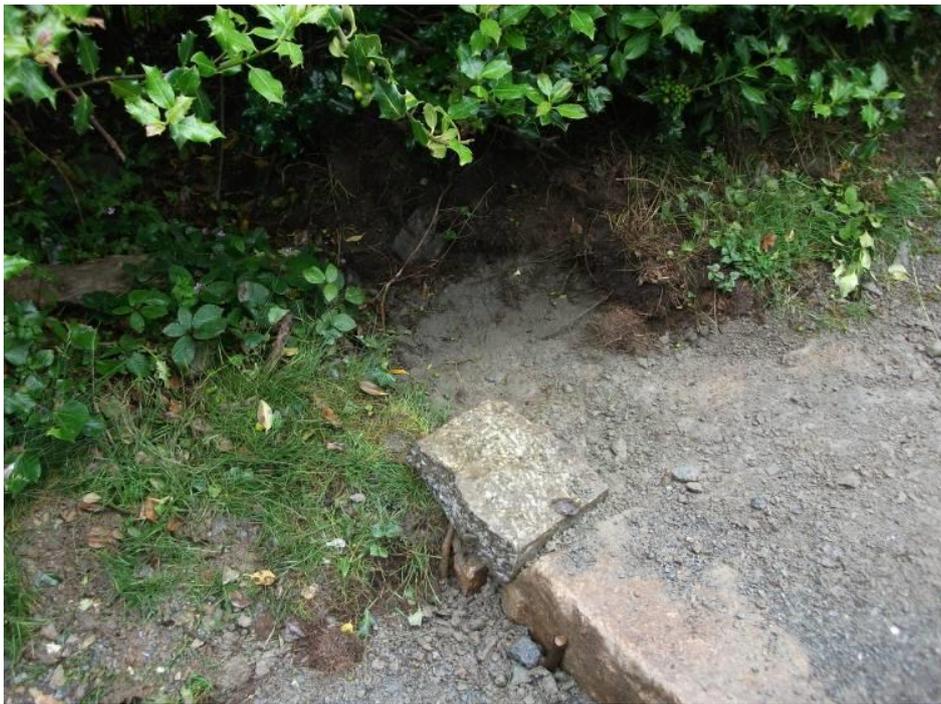
These photos have been taken after the new granite steps had been put in and with the new drainage channels in place.

- Granite steps were chosen as the preferred material for the new steps. This material is very strong, sustainable and will be almost maintenance free. The granite was purchased from a local quarry.
- The contractor removed all the old wooden steps from the site first and then levelled the ground so it would be easier to carry the granites up to the top of the path.
- Using a power barrow granites were carried up to the top of the site and the steps were put in starting from the top of the hill.
- Stone lined drainage channels were put in at strategic locations along the path (4 in total), with the main one at the top of the steps.
