CP60 Trevilly Project Summary

The Trevilly section of the South West Coast Path is located close to Mill Bay (Nanjizel) near to Land's End. This popular section of coast path predominantly consists of maritime heath on granite based geology.

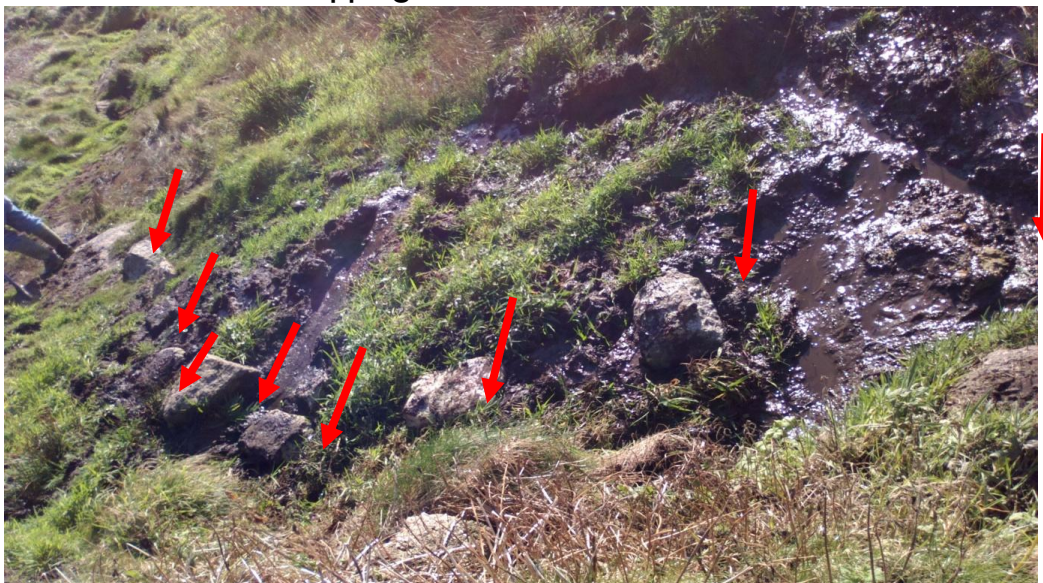
8x stepping stones & shallow ditches.

Granite stepping stones were used to provide a clear surface for walkers. Additional drainage ditches have been cut to enhance the drainage of the area. The benefits from this project include improved access to the beach at Nanjizel from the main access point at Land's End.

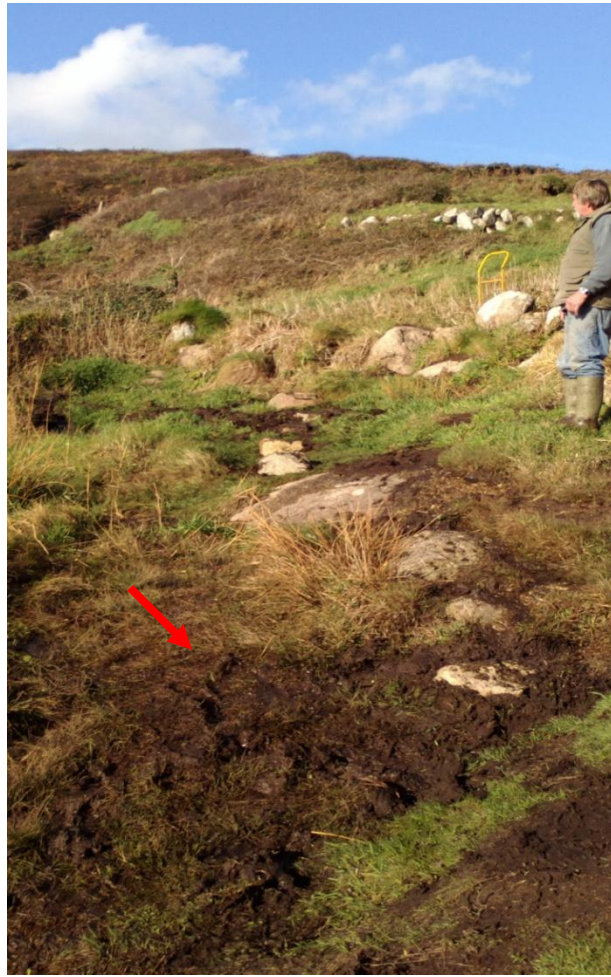
1x stepping stone.

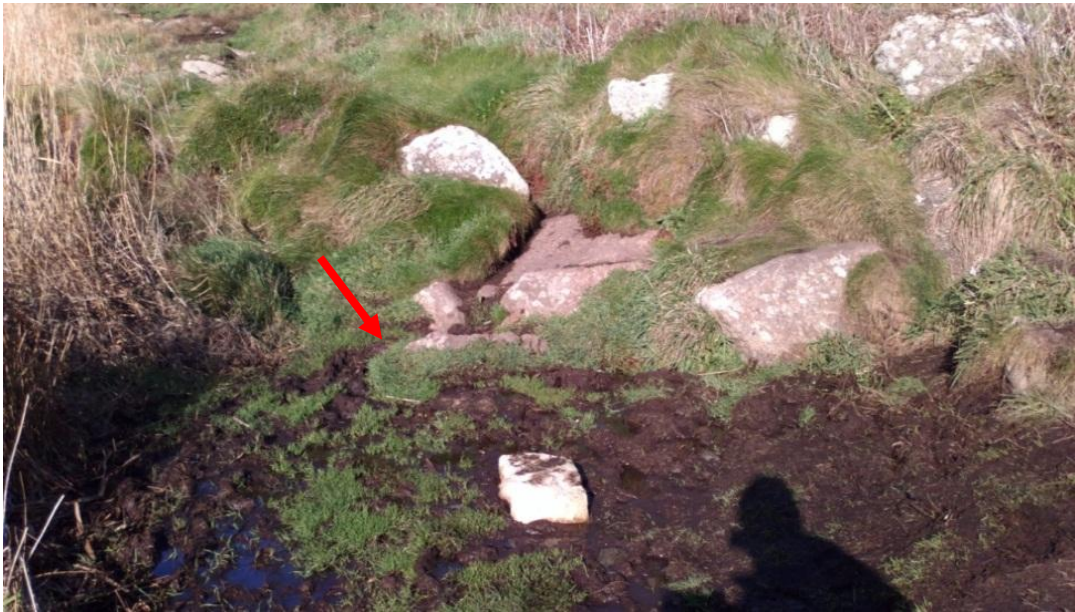
1x stepping stones.
