## CP62 – Gwennap Head: Roskestral west cliff

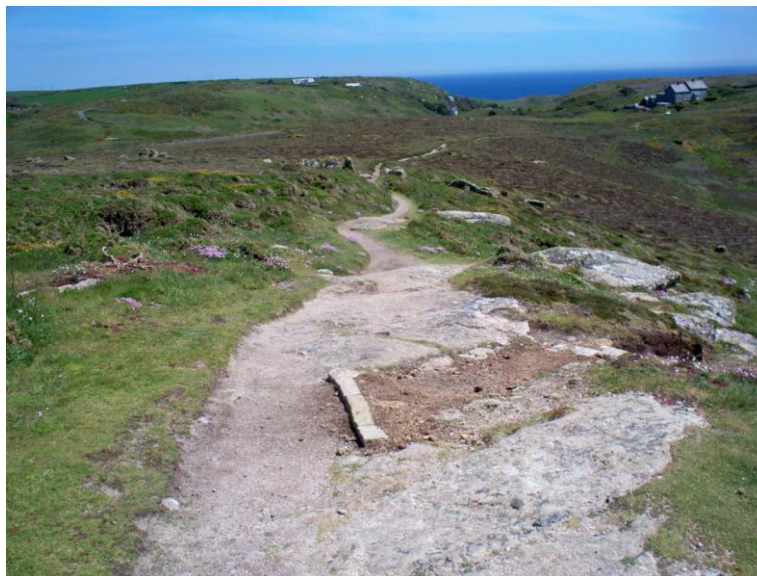
Cut off Drain

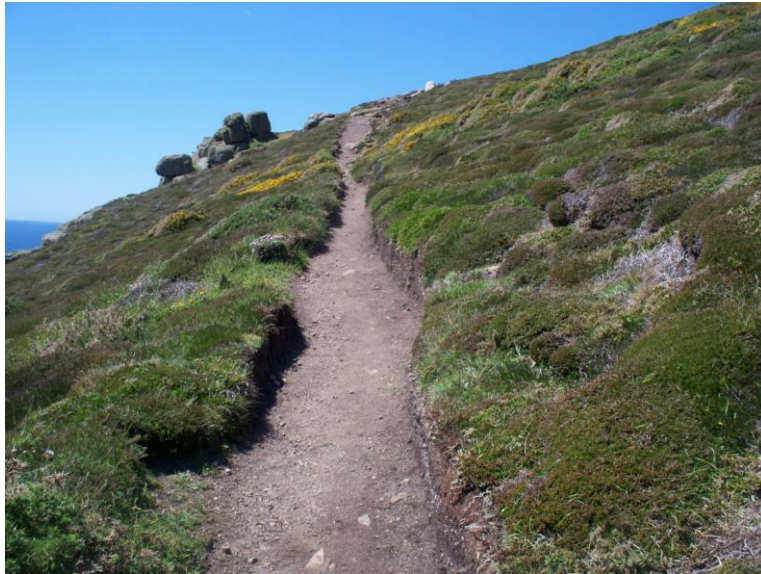
Loose Stone

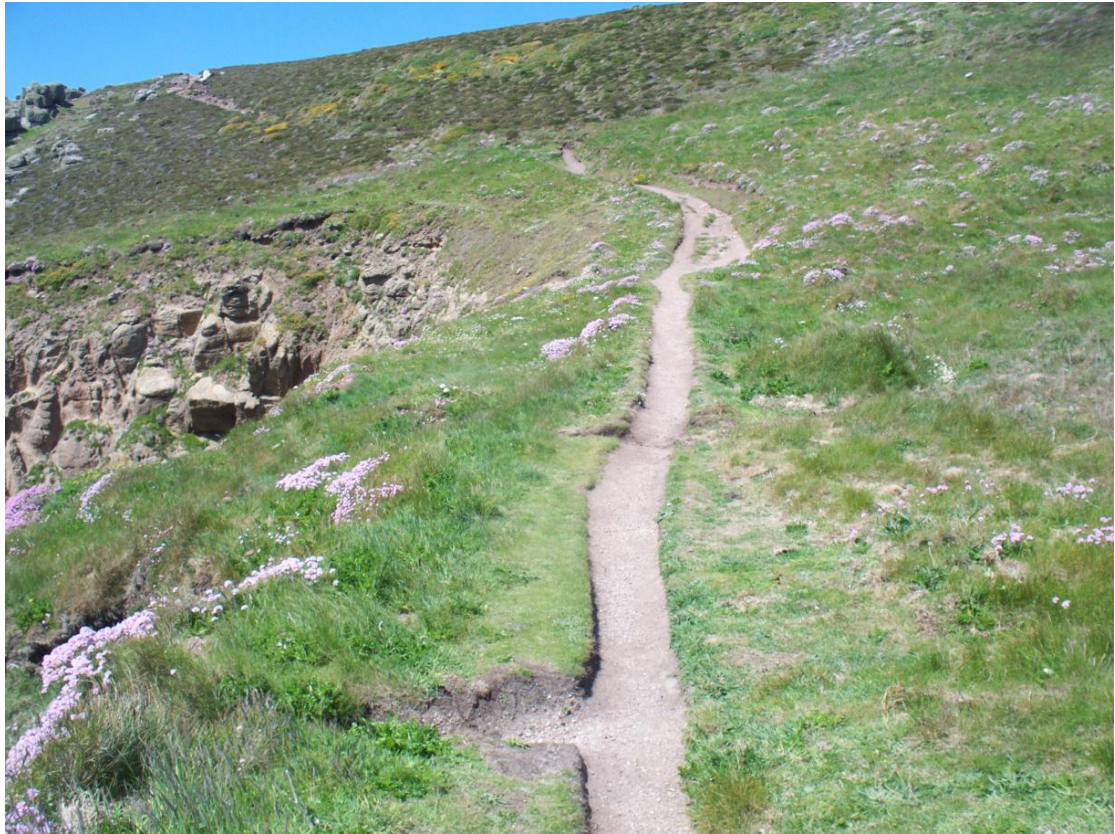
Cut off and loose stone
