## CP 63 Nanjizel

The Nanjizel section of coast path is located at Mill Bay (Nanjizel) near to Land's End. This popular section of coast path predominantly consists of maritime heath on granite based geology.

**Pictures from the project  
NANJIZAL.**

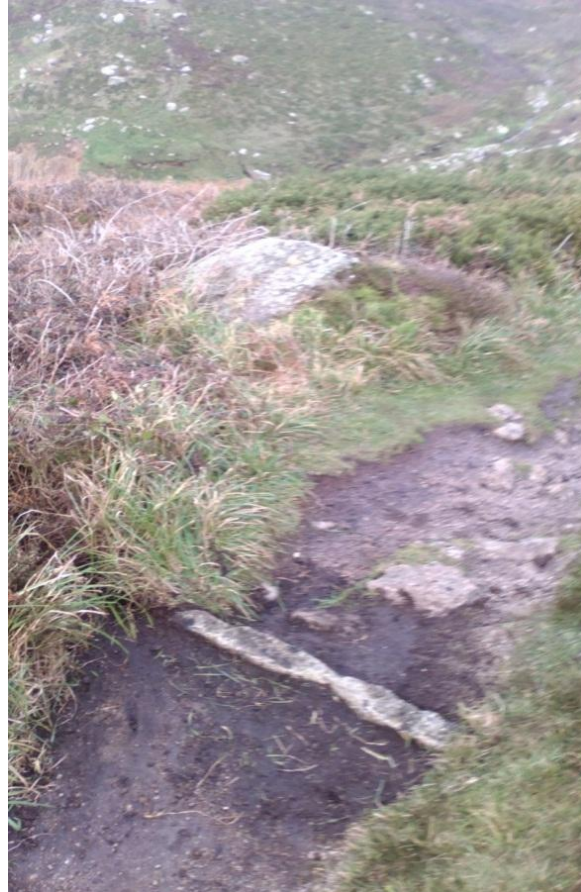
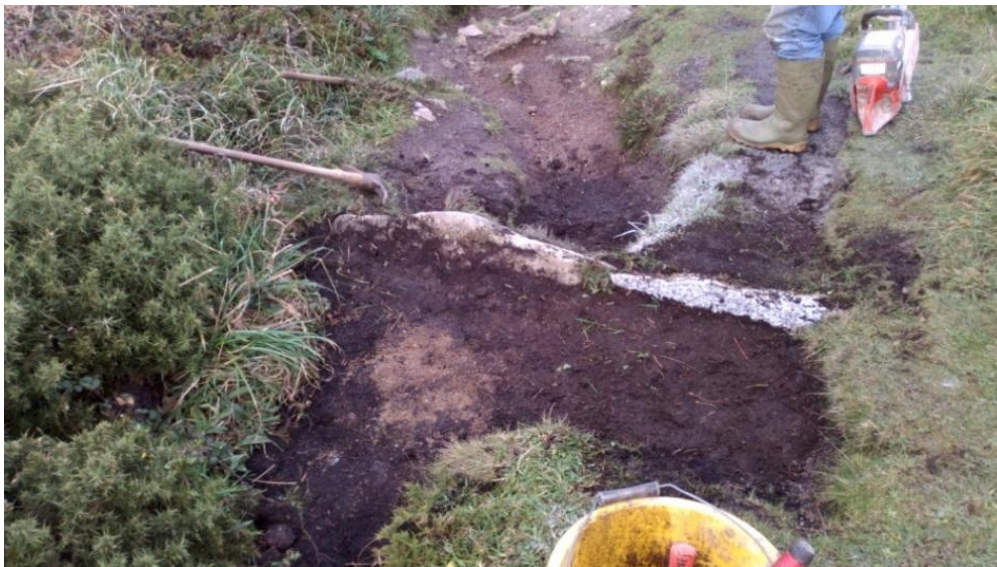
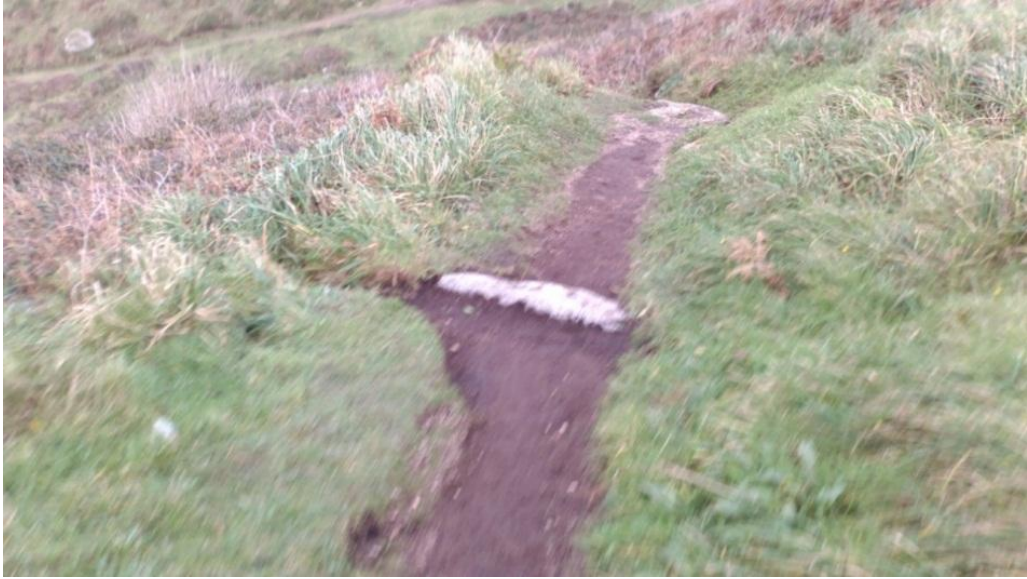
A,B & C.  
3x granite cut off at top of hill.

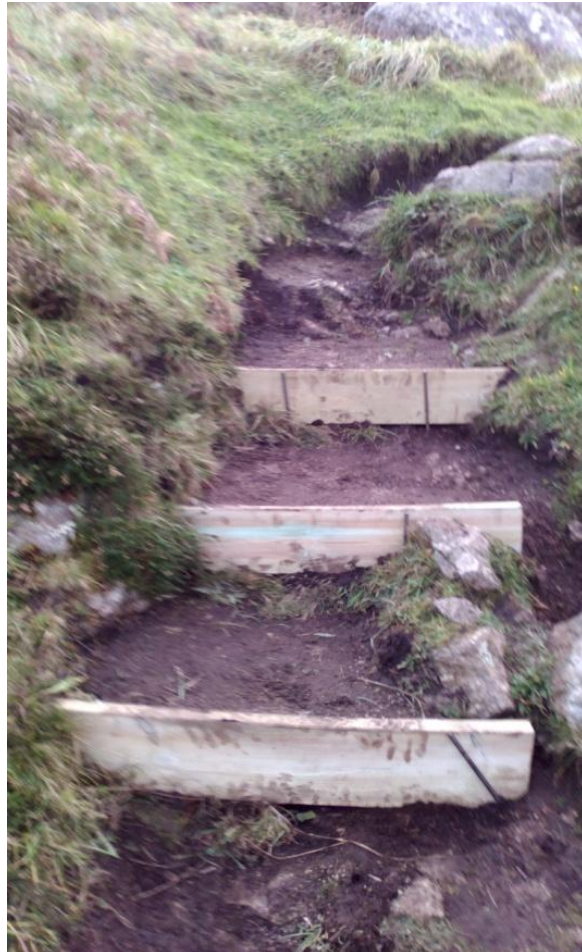
D. 3x timber steps

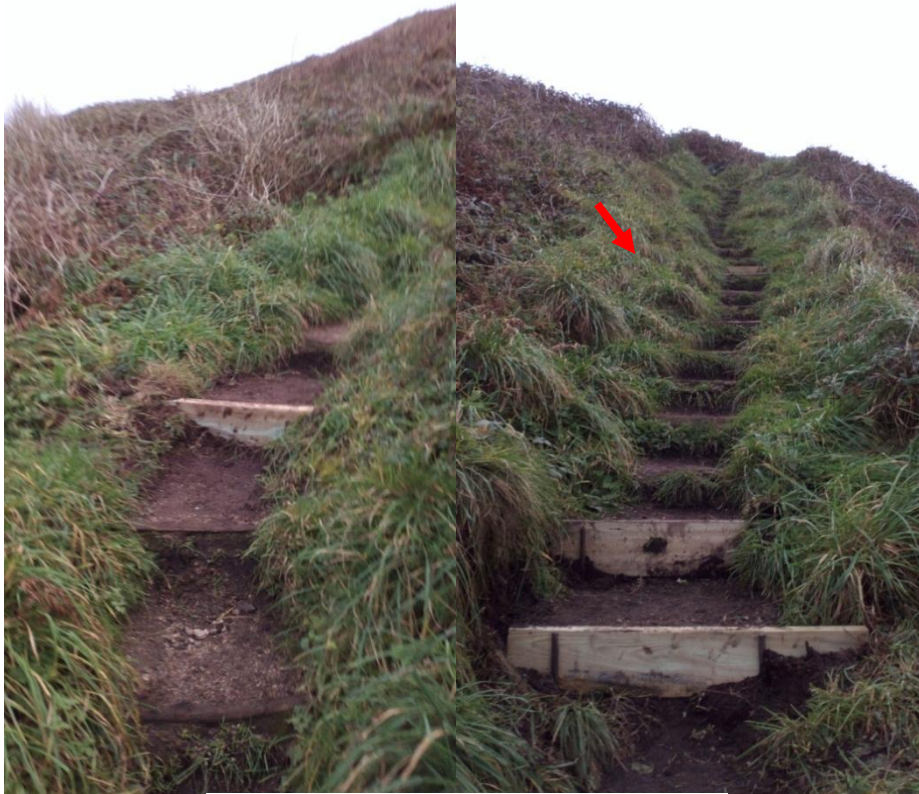
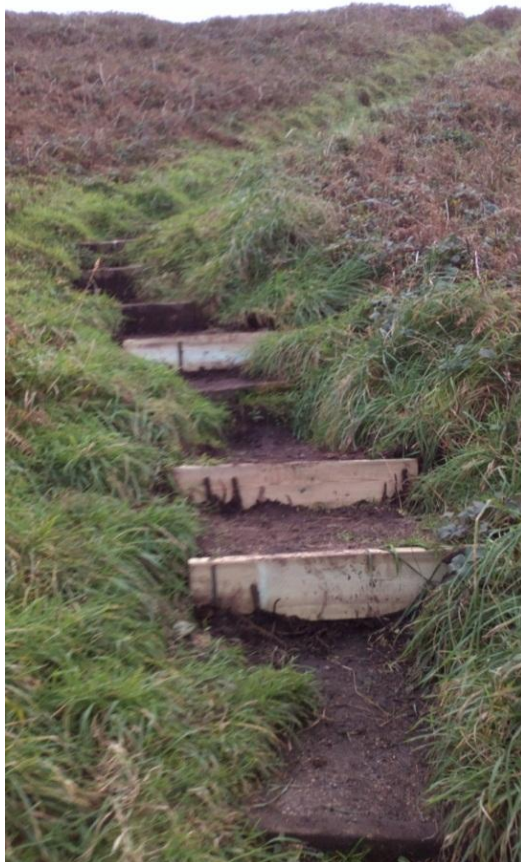
E.7x replacement timber steps

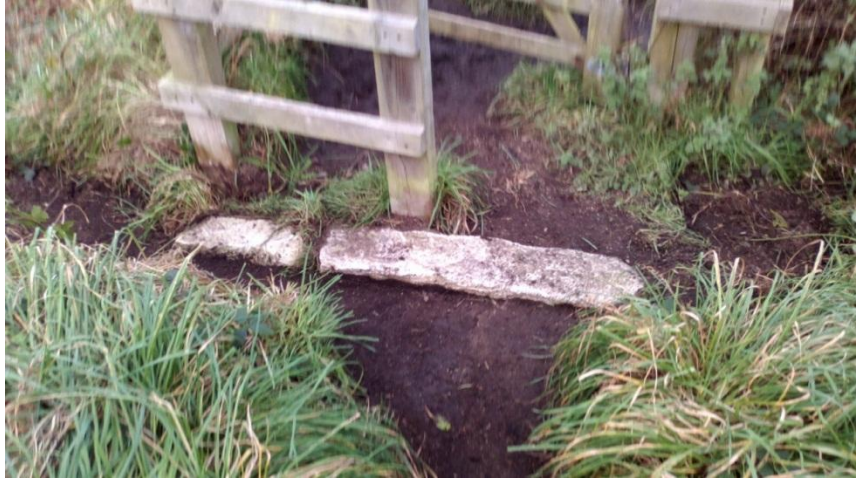
F. Modified from plans as discussed, 1x granite cut off above kissing gate.

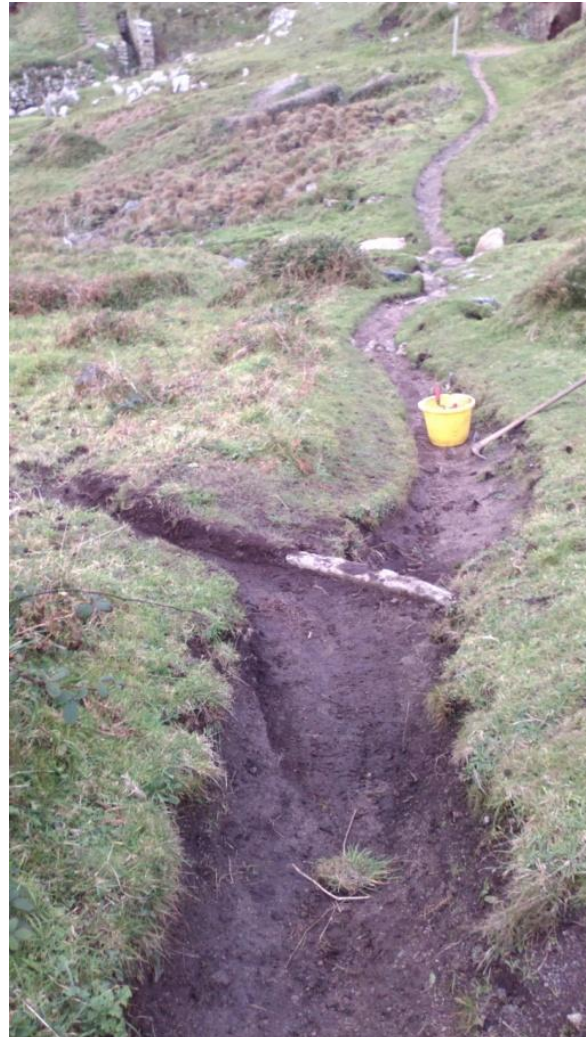
G. 1x granite cut off below kissing gate.

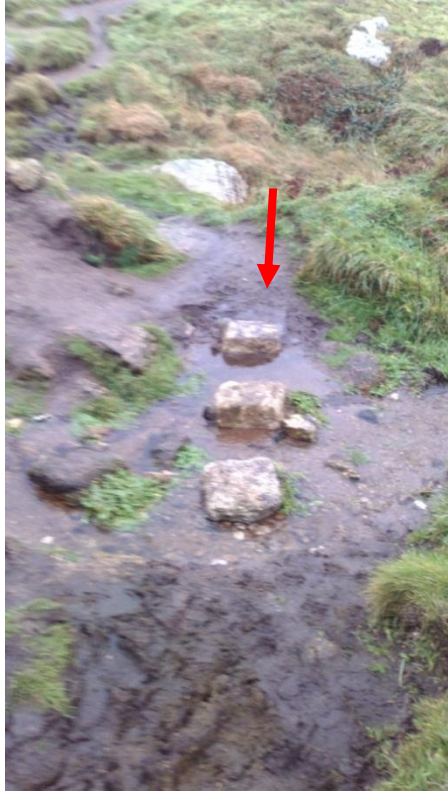
A. 3x stepping stones across stream.

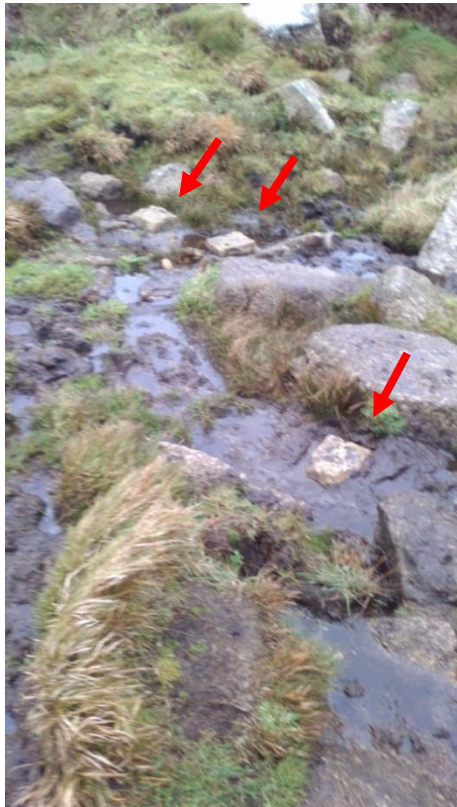
B. 3x stepping stones across marsh.
