## GSWW 333 – PENDOWER BEACH & CARNE IMPROVEMENTS

During a bi-annual survey of the South West Coast Path, a number of improvements and repairs were identified around the Carne Beach area of the coast path.

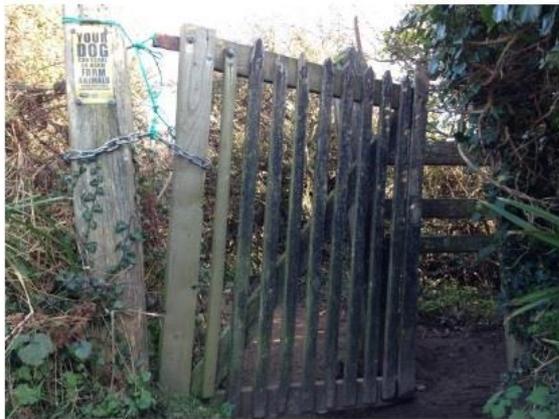
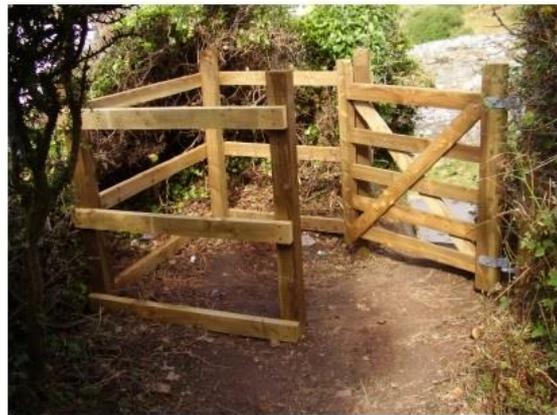
### New Kissing Gate

The landowner had been making an attempt to keep this gate usable over the years by tying it together with chains and string. The enclosure area was also overgrown and not very big. We have replaced this with a new kissing gate with room for walkers with big rucksacks and have cleared the vegetation from around here.

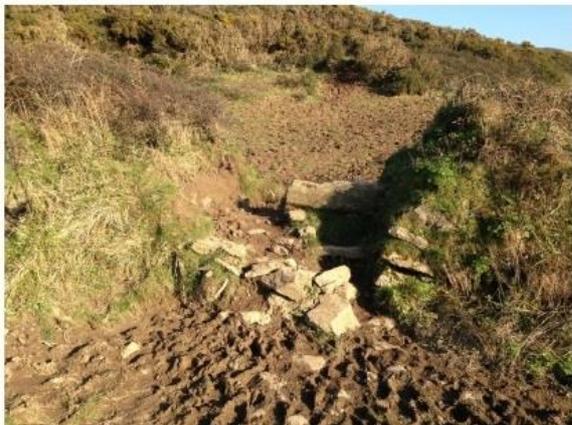
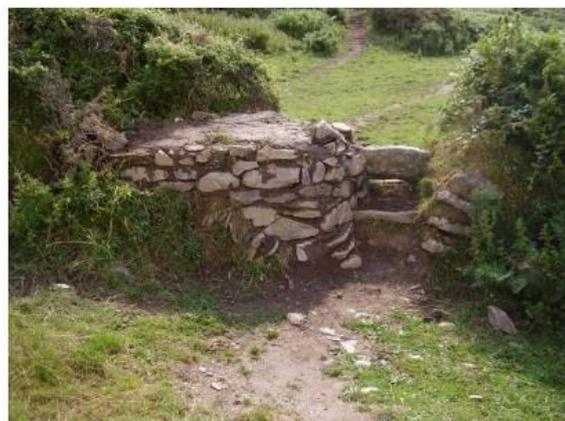
### Re-building historical stile

The previous tenant of this land had sheep, the sheep had been allowed to roam the land here and in turn had been slowly pulling down the wall alongside this old stone stile. As a result, walkers had been using the wall area rather

than the stile as a means of passage for the coast path. The wall has been re-built incorporating the original stile, and therefore retaining an original feature.

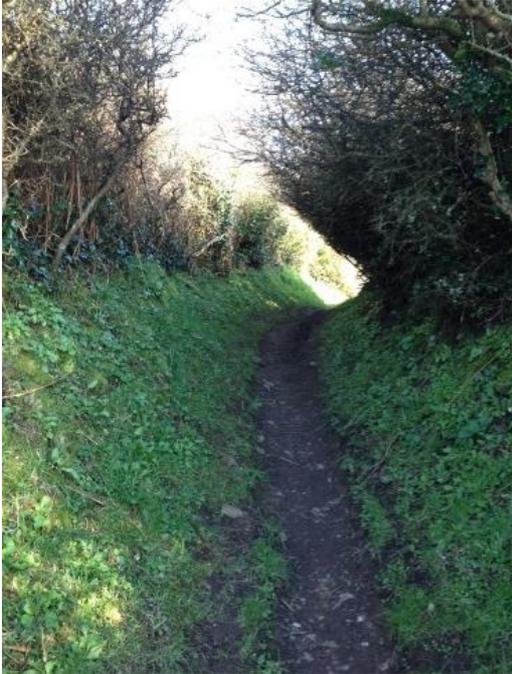
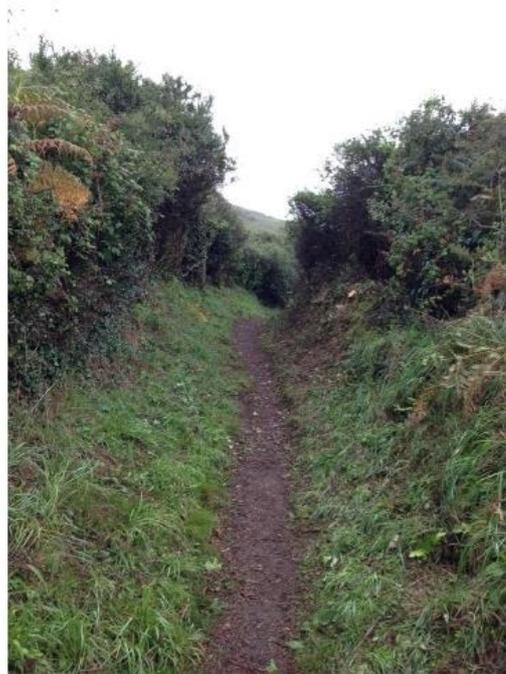
### Scrub clearance

There were a number of places along this stretch of coast path where the vegetation had started to push walkers into the inland side of this path. Clearance has been undertaken to make sure there is no more encroachment and walkers can enjoy using this path unimpeded.

The project was started in July 2013, at which time the contractors did the kissing gates, the re-building of the stile and the new path. However, in keeping with Wildlife and Countryside Act 1980 guidance, the clearance was undertaken in September 2013.

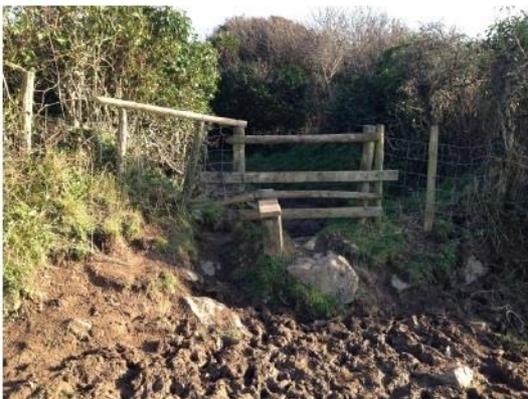
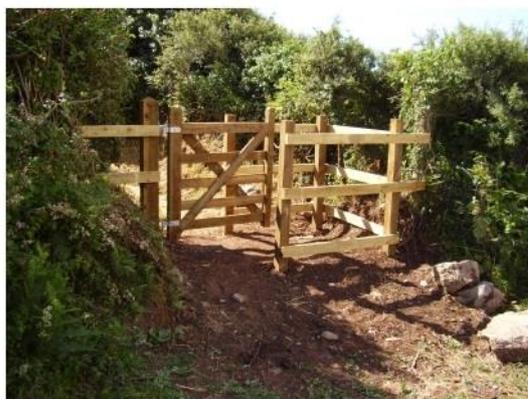
### Access Improvements

In order to make the South West Coast Path more accessible for all, it was decided to take out an old wooden stile in a boundary hedge and replace this with a new kissing gate. The previous tenant kept sheep and the old stile, although had a dog gate which allowed access for dogs, was covered with sheep fencing. The landowner has taken back the land and is using it for grazing cattle and so the kissing gate will control cattle and also allow better access for walkers.

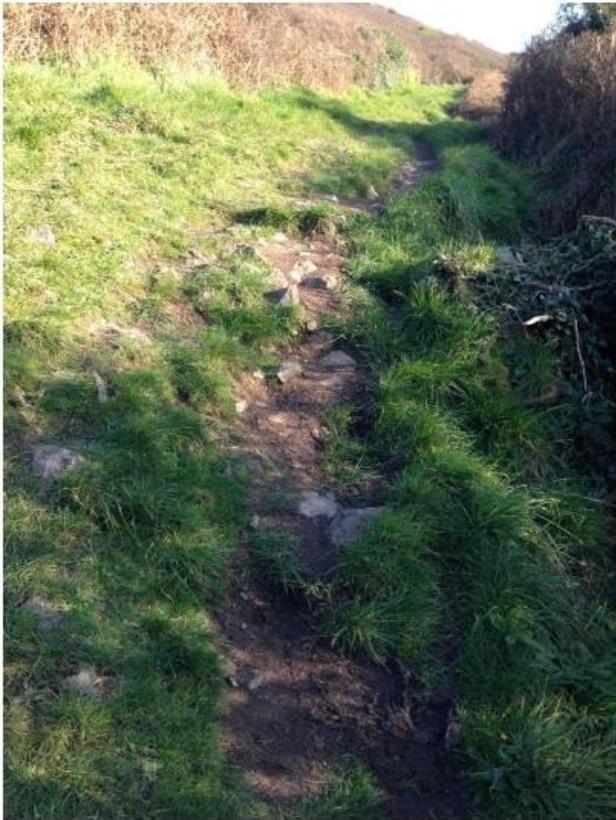
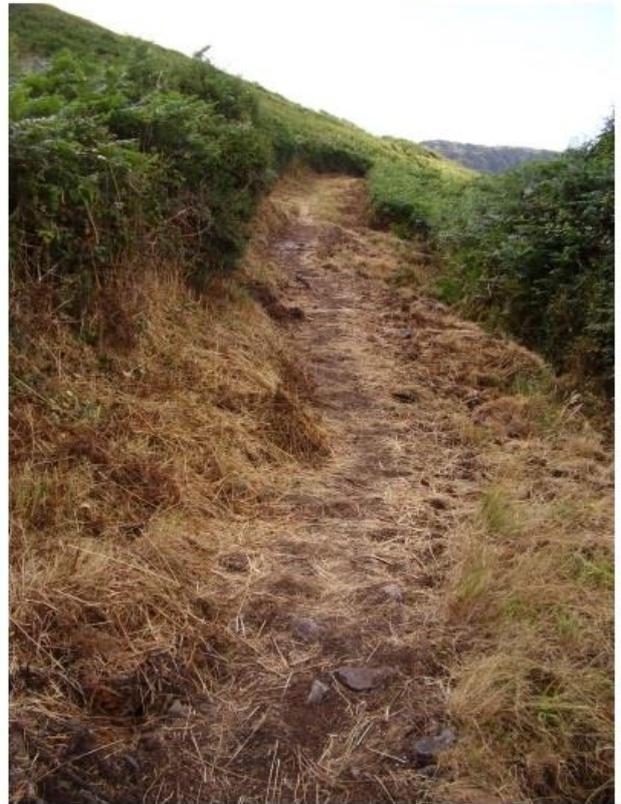
## Surface Improvements

While undertaking a survey of the path, it was noted that there was a particularly rough section of terrain with what appeared to be a large open ditch to the seaward side. A new path was cut approximately 1.5 metres inland to keep walkers away from the ditch. The ground was levelled out and a number of steps were installed at the start of this section to counterbalance the change in levels.
