CP42 Sharrow Steps, Whitsand Bay.

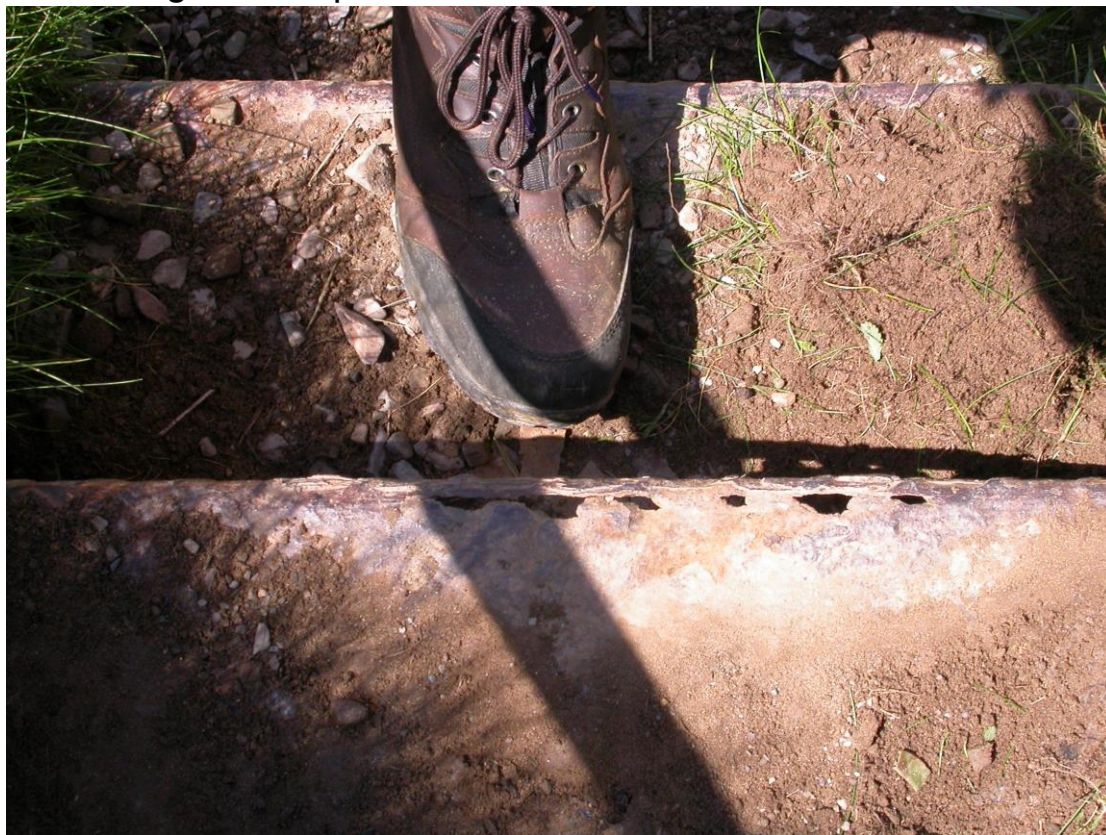
The previous steps were around 20 years old. The proximity to the sea and level of wear caused by walkers had led to serious corrosion of the step treads. Many treads had holes in the plates which were patched and in an unsatisfactory condition. Without replacement there would, in a short period of time, this path would need to be closed.

Steel step tread showing severe corrosion and closed chequer plate construction

The proposal was to replace the steps with a new flight – once more fabricated out of steel, hot dip galvanised and constructed in such a manner that the treads could be replaced individually in the future. The treads were constructed from an open grid material for better grip. The project has been completed to expectations and is delivering the anticipated benefits.

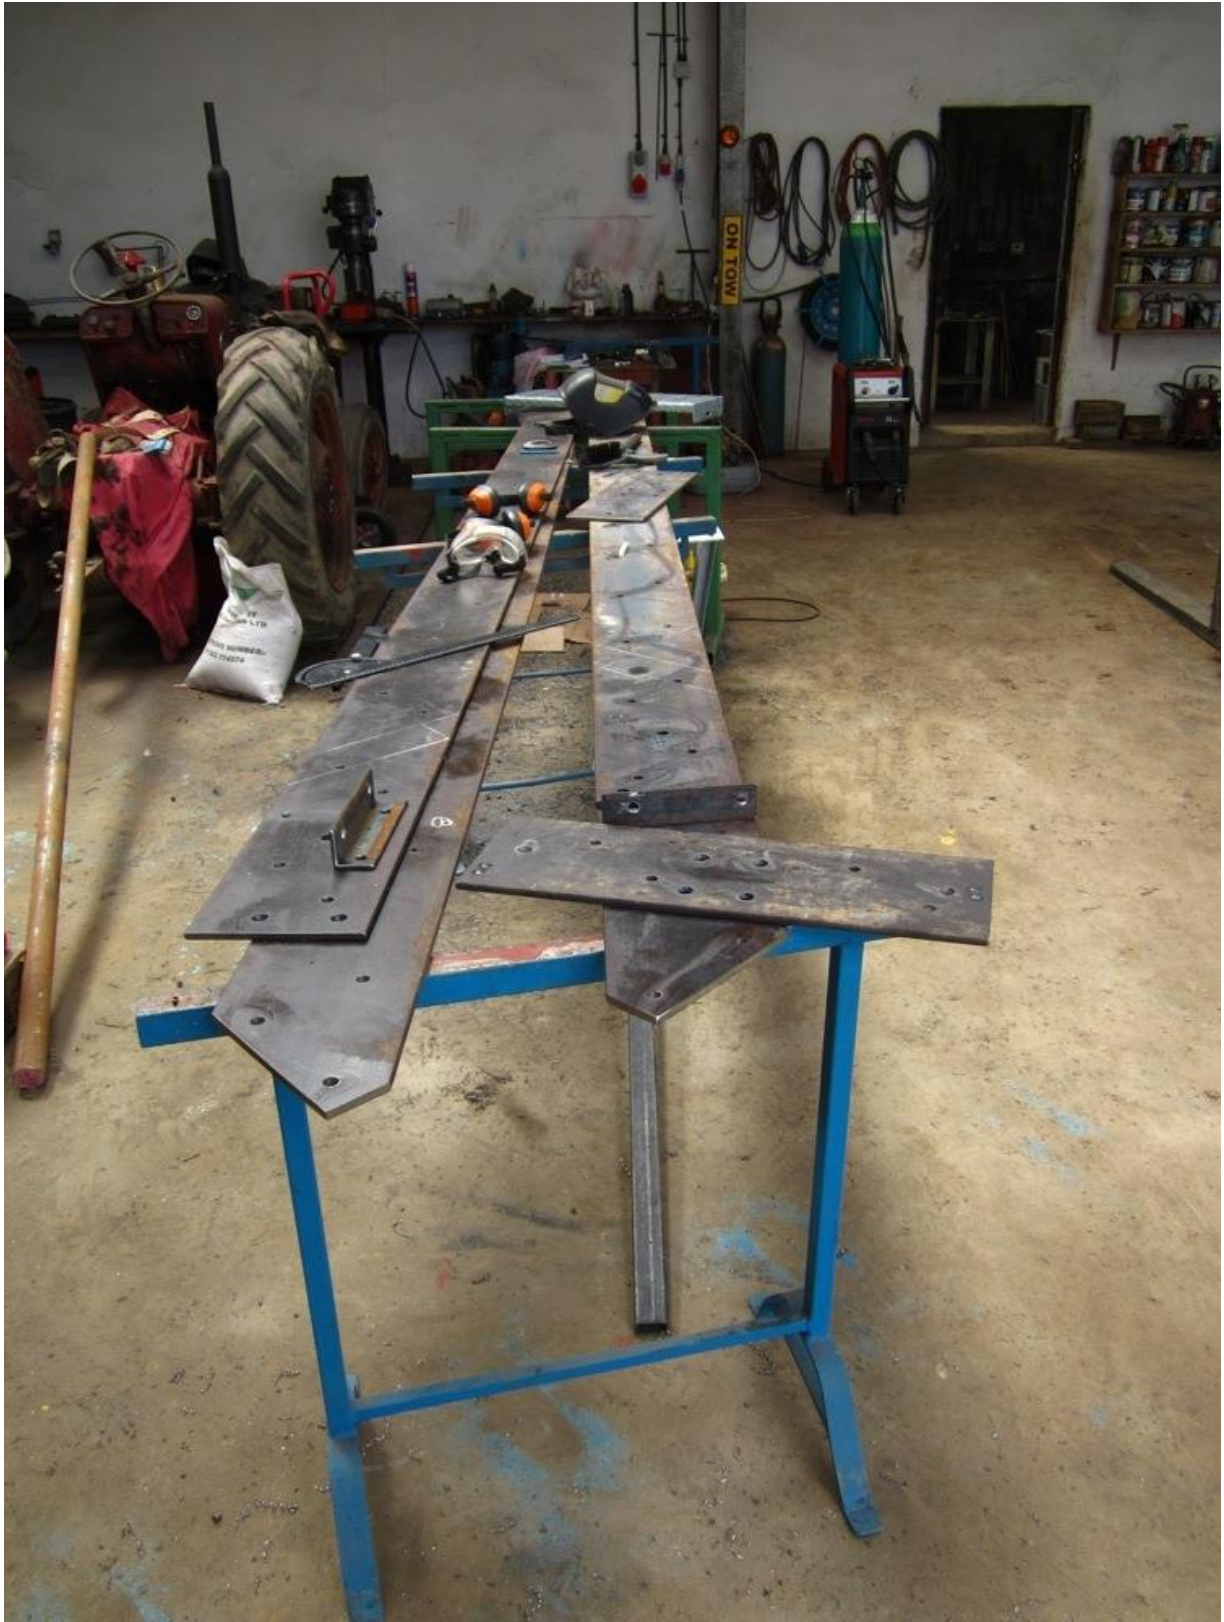
Steps during fabrication

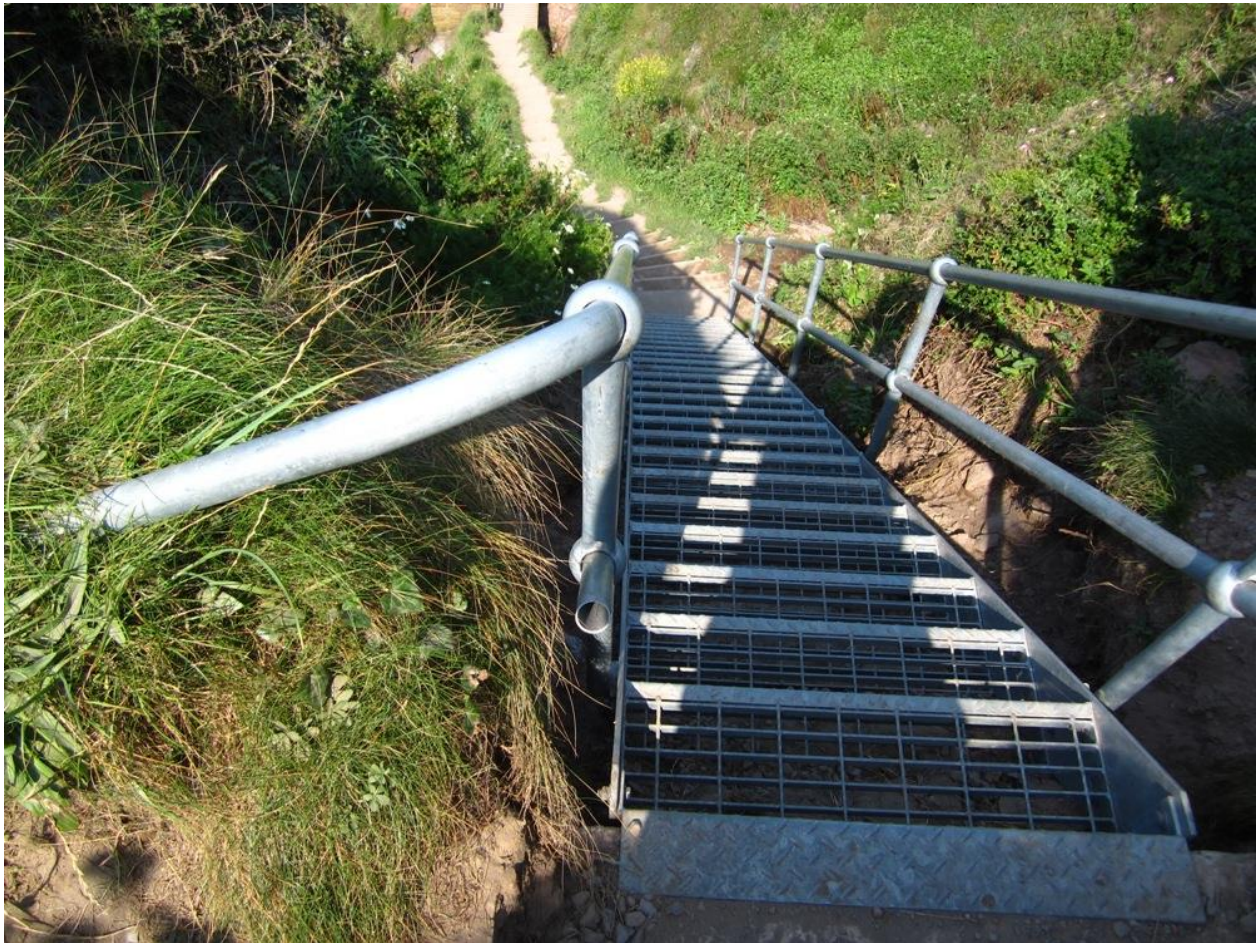
Sharrow steps on completion showing handrails and improved tread construction
