GSWW 304 Morte Point

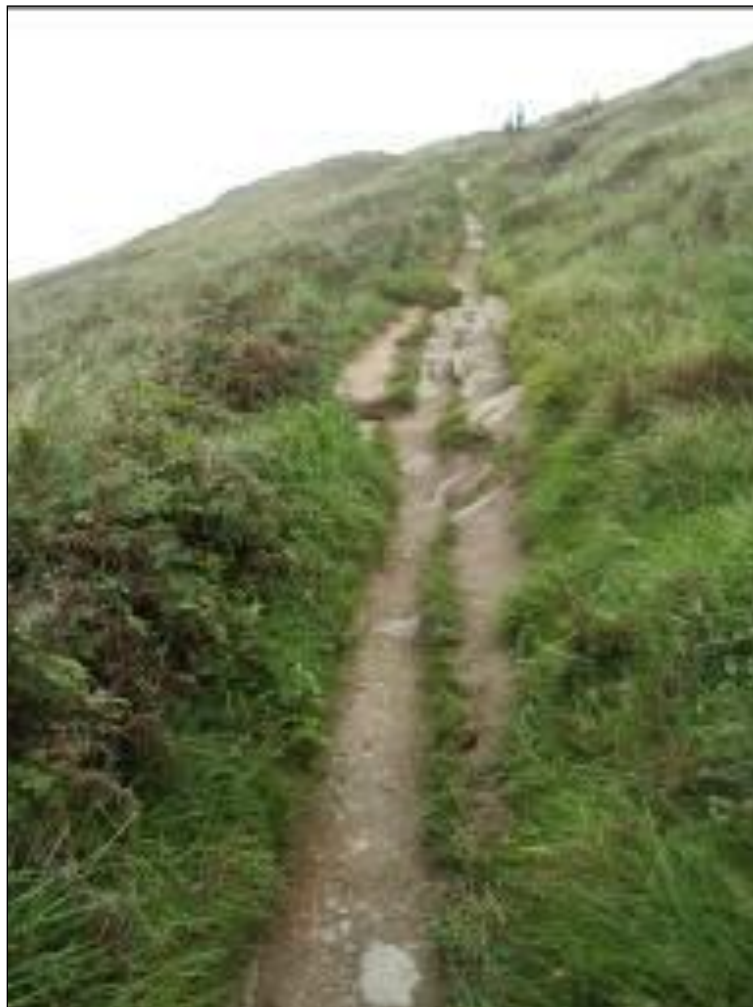
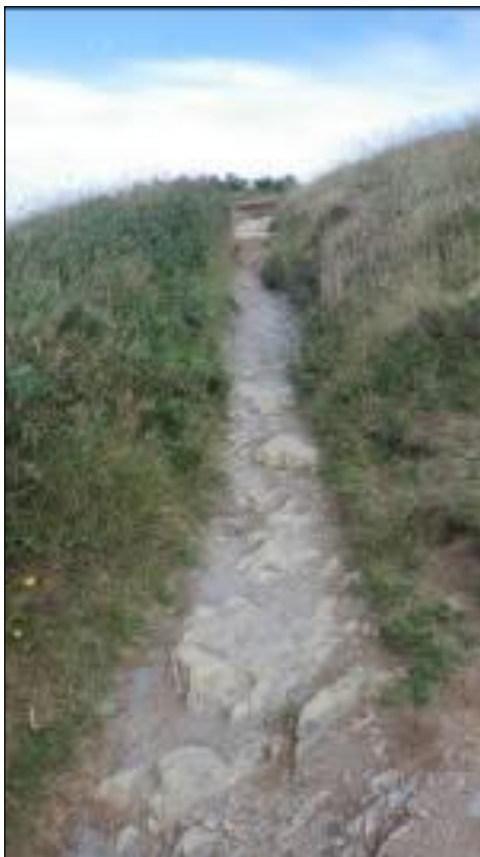
Before Photos:

This 100 metre stretch of SWCP is on the north side of Morte Point going down a steep slope. The original path was very rocky in places and walkers had taken a number of short cuts to avoid the path causing erosion problems. The path has been rock drilled off in places and edges dug off to provide a more defined path and resurfaced with shillet.
