GSWW 401 Porthallow

A number of path improvements had been identified at the half way marker point of the South West Coast Path National Trail at Porthallow on the Lizard. These included moving the path from an enclosed 'tunnel' effect area to the field above. This means walkers are now able to overlook Porthallow on the approach. It will also mean that the path will stay drier as it is now able to get light to it, unlike before.

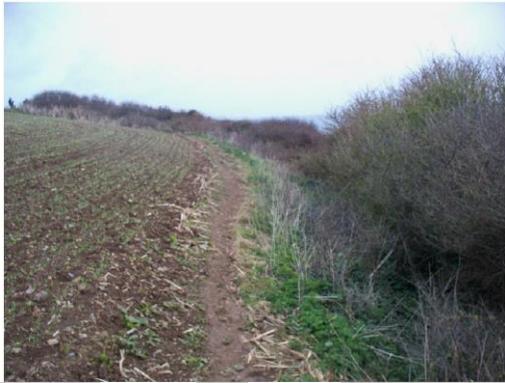
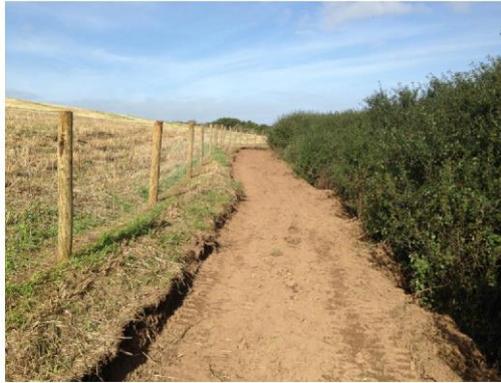
Field before and after re-grading and fencing:

As part of this movement, we have fenced off the path so that the tenant farmers cattle will not be able to poach the coast path and are separate from walkers on the coast path here.

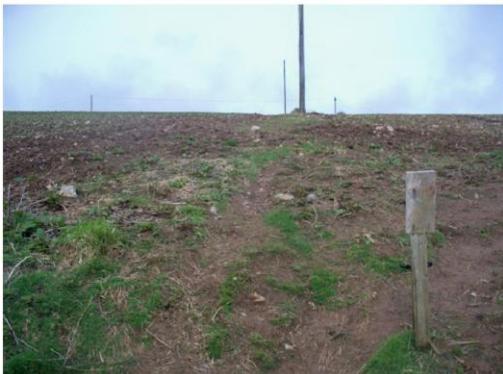
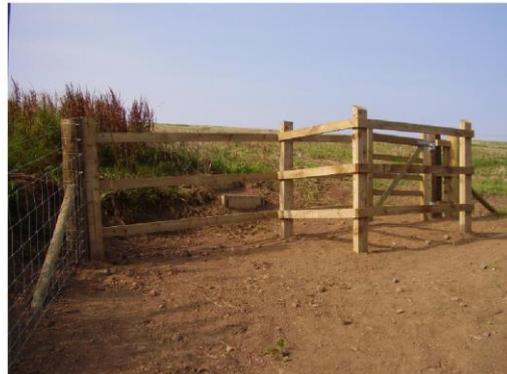
From the Coast Path there is an inland link which is part of a circular route back to Porthallow and so, in keeping with Highways Act 1980 law, a kissing gate was installed within the fence line to allow the inland route to be unobstructed.

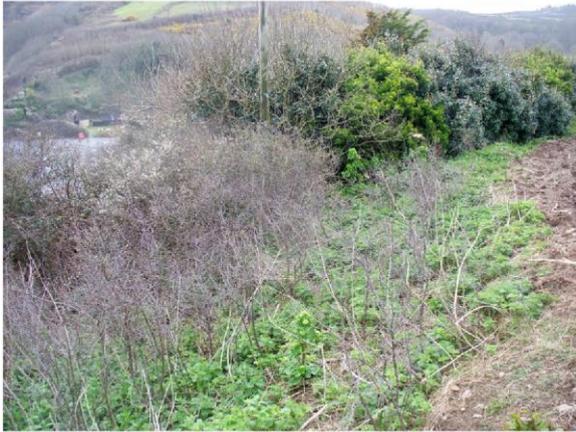
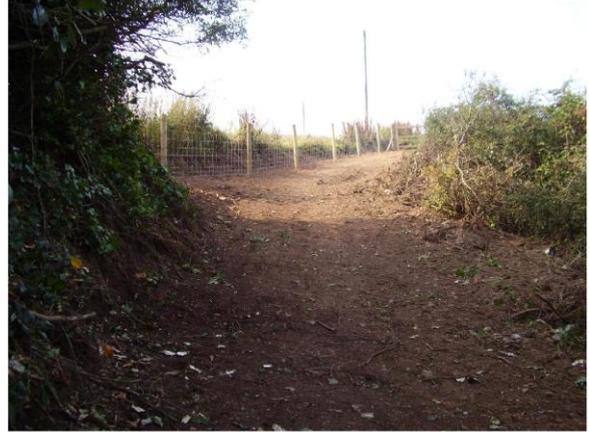
The definitive line of the footpath was re-opened by cutting through scrub and levelling off the path. This was also a way of keeping walkers from a particularly steep and slippery section of path.

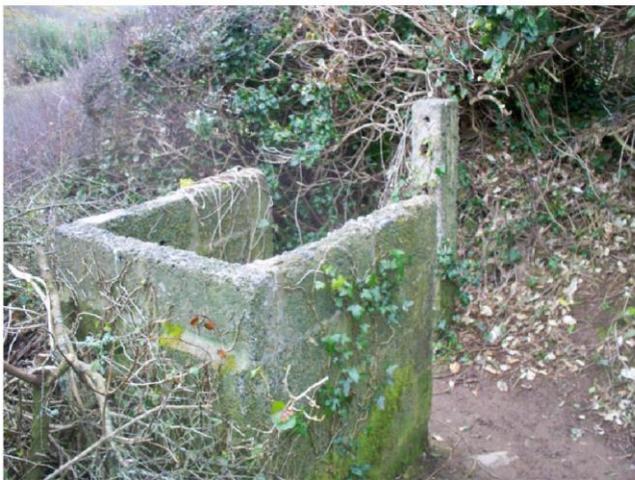
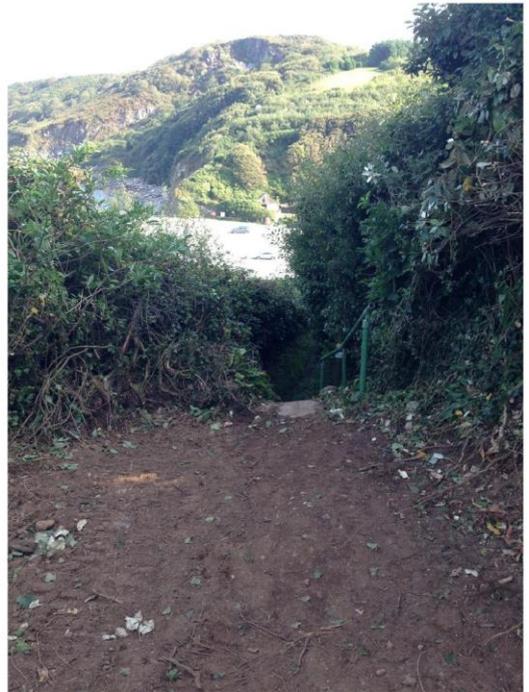
The old kissing gate enclosure was removed from the top of the steps as this is no longer needed and was an eye sore at this location.

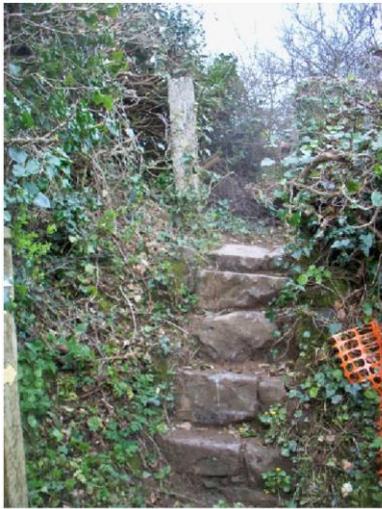
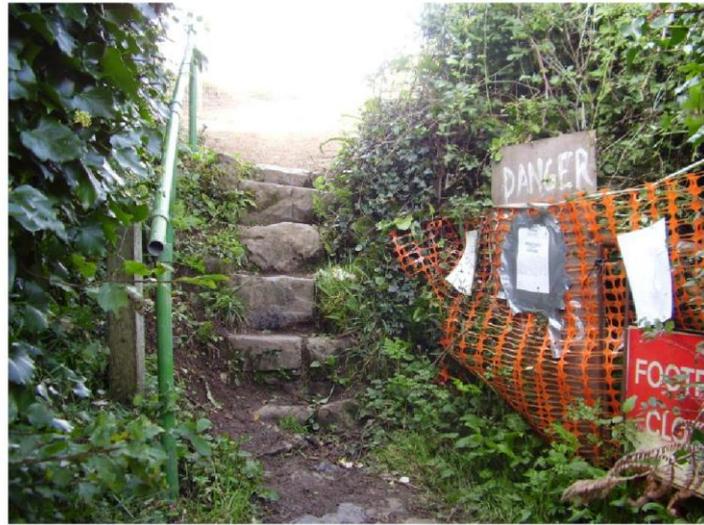
Just below this is a flight of steps, the steps being made of a local stone, Serpentine. These become very slippery when it is wet, so we put in a new handrail to aid users up and down.

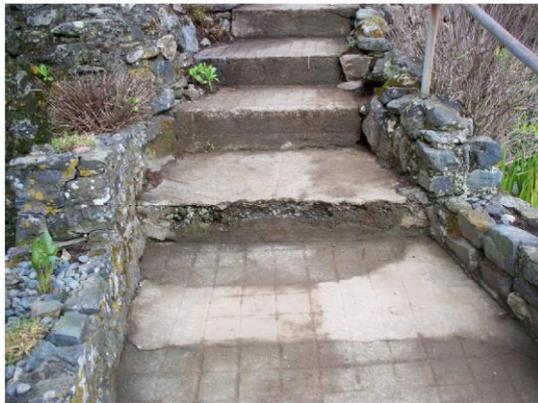
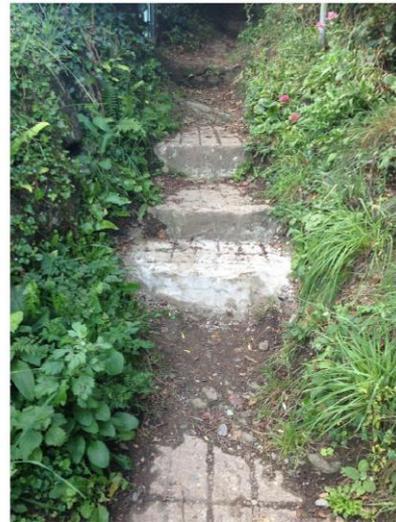
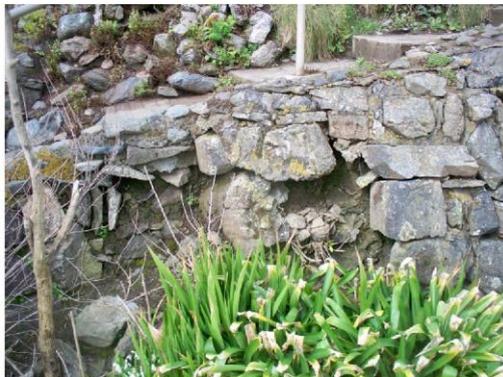
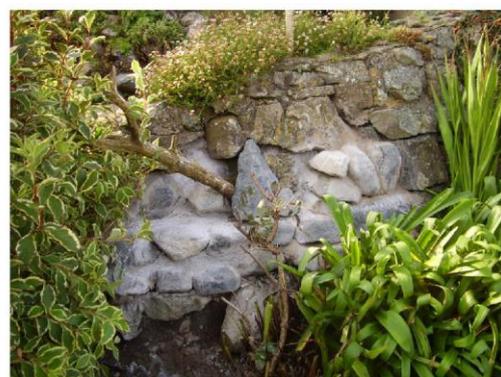
In order to improve users experience of the coast path, some new steps were put into the existing ones coming out of the village and the fronts of any which had eroded were tidied up. The wall below the steps was stabilised to make sure any further damage here is minimal.
